Electron irradiation-induced destruction of carbon nanotubes in electron microscopes

Kristian Mølhave^{a,*}, Sven Bjarke Gudnason^a, Anders Tegtmeier Pedersen^a,
Casper Hyttel Clausen^a, Andy Horsewell^b, Peter Bøggild^a

^aMIC—Department of Micro and Nanotechnology, NanoDTU, Technical University of Denmark, DK-2800 Kgs. Lyngby, Denmark

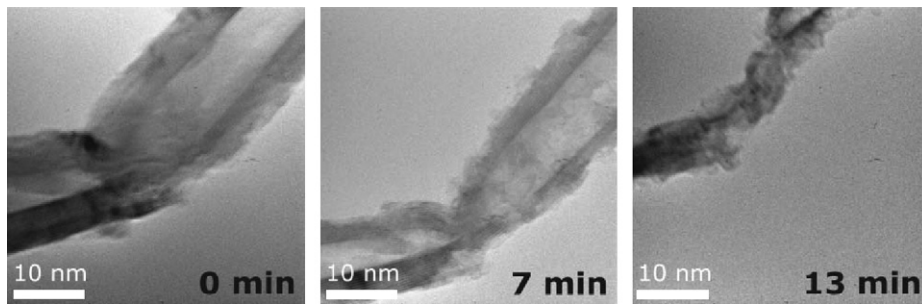
Fig. 1. TEM image sequence showing the progressive destruction of the carbon shell structure with respect to time under intense electron beam irradiation.

The TEM image sequence in Fig. 1 shows a multi-walled carbon nanotube slowly being destroyed by the electron beam exposure. After 15 min at high-beam current the nanotube structure has been completely removed. Even very large multi-shell MWNT, as the one shown in Fig. 2, can be considerably damaged by prolonged exposure to the beam.

From the cross section of both the small (Fig. 1) and large nanotube (Fig. 2), it seems that a considerable fraction of the outer shells has been removed, while the inner shells apparently are less susceptible to the observed irradiation-induced damage. Irradiation-induced cross-linking of the carbon bonds would be expected to appear throughout the nanotube and convert the shell structure to amorphous carbon. Knock-on collisions are expected to mainly attack graphene planes perpendicular to the beam, and the damage seems to be considerable to the planes parallel to the beam in the outer shell. The nanotube does not collapse as reported in an 800 kV TEM experiment [14]. In both nanotubes (Figs. 1 and 2), the damage to the outer shells could be interpreted as the formation of pits in the structure. Such pits are known to form by oxidation [15], which would also explain why material appears to be removed from the nanotube surface, and not in a uniform manner throughout the nanotube. The question is then what causes oxidation in the vacuum environment.
